CF6-6D ENGINE SHORT-TERM PERFORMANCE DETERIORATION

W.H. Kramer, J.E. Paas,
J.J. Smith, and R.H. Wulf

GENERAL ELECTRIC COMPANY
AIRCRAFT ENGINE GROUP
CINCINNATI, OHIO 45215

NASA Lewis Research Center
Contract NAS3-20631

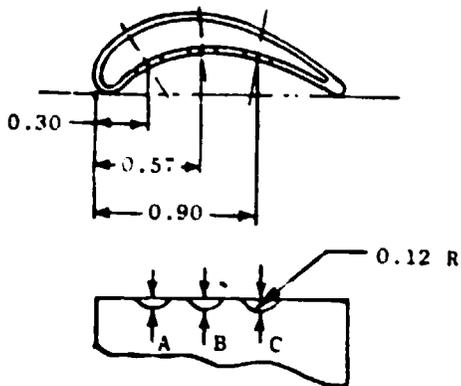
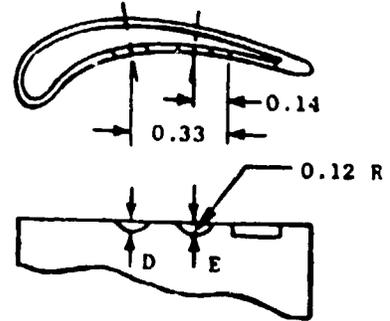
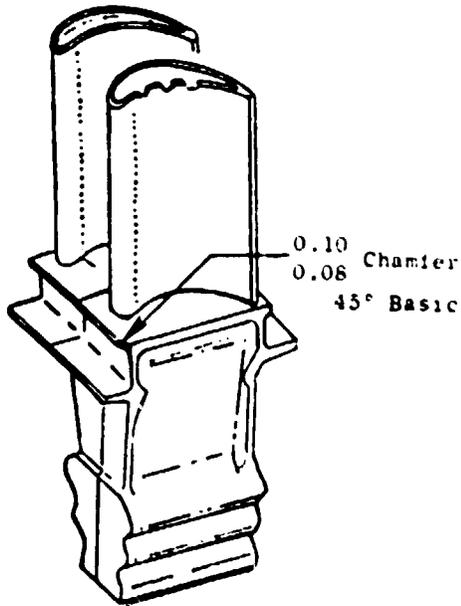
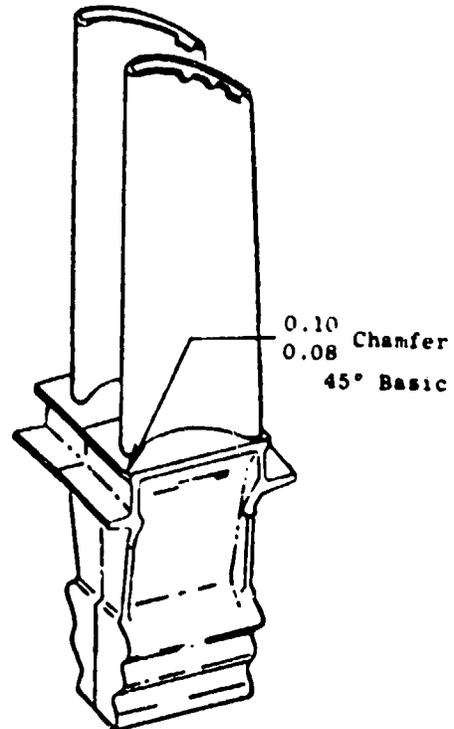
Figure A-1. Notched H¹ Turbine Blades.

Blade No.	Notch Depth (mils)		
	A	B	C
1	10	20	30
28	10	20	30
14	15	35	60
41	15	35	60

Blade No.	Notch Depth (mils)	
	D	E
1	10	20
30	10	20
16	20	50
45	20	50

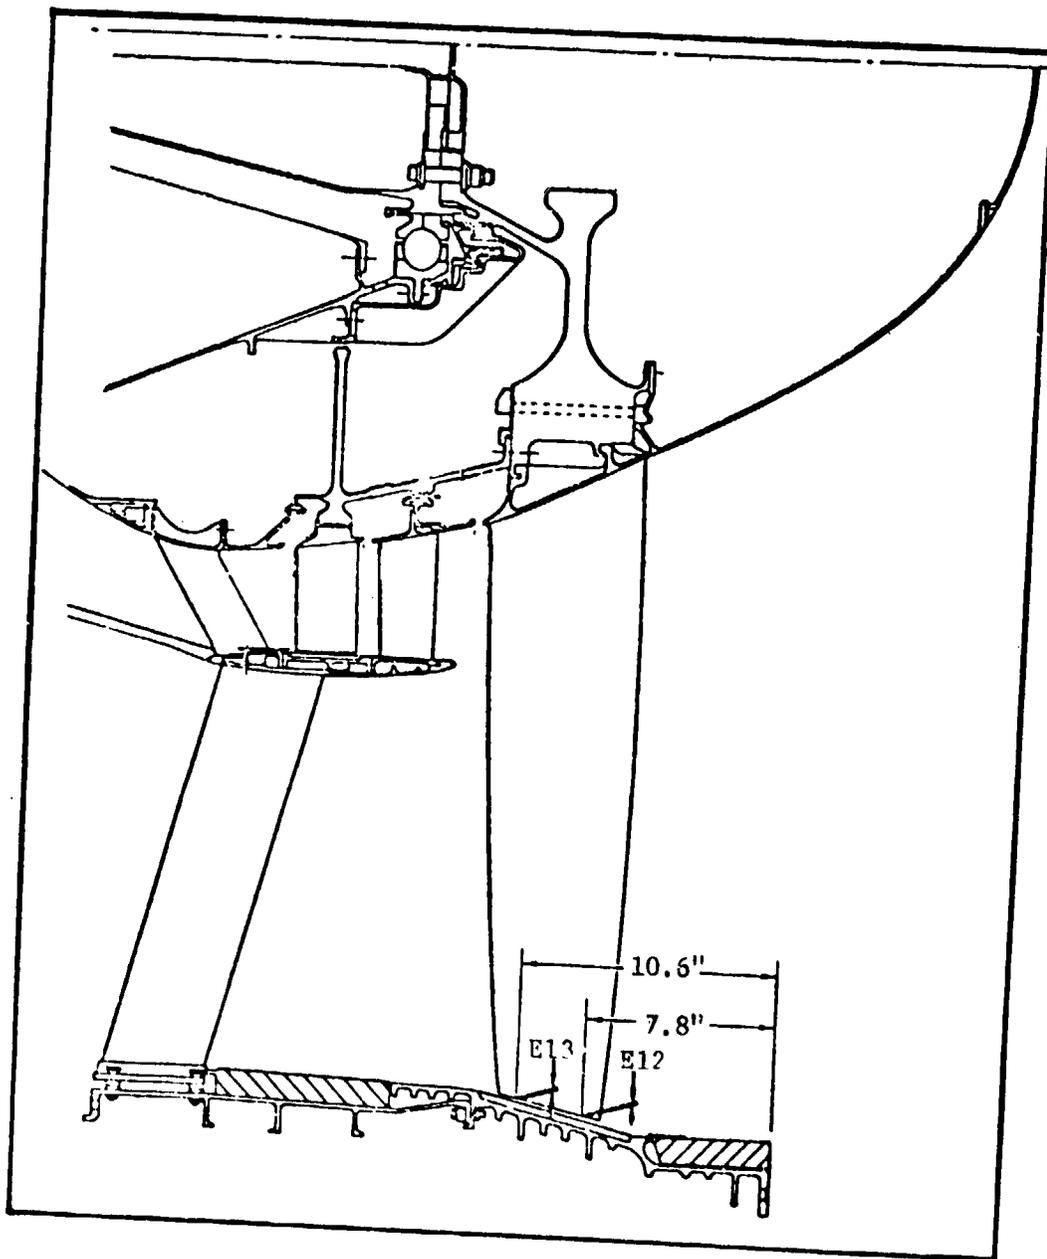
Figure B-2. Locations of Stage 1 Fan Blade Tip Clearance Measurements.

The Stage 1 fan blade tip clearances for ESN 451507, as calculated from the blade data (Tables B-I and B-II) and the shroud data (Table B-III), are presented in Table B-IV. The results reveal very little differences from the Shop Manual requirements.

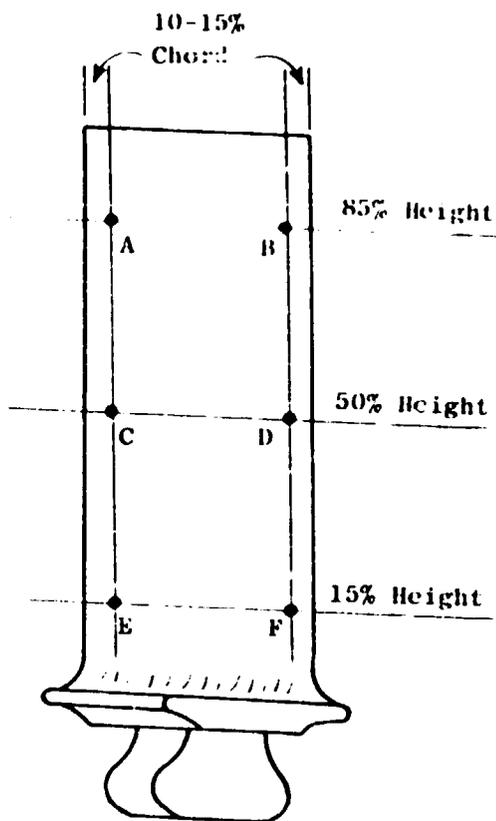
Figure B-4. Location of Surface Finish Measurements - HP Compressor Rotor Blade.

Average Airfoil Surface Finish = 16μ inches AA
 Average New Part Finish = 15μ inches AA

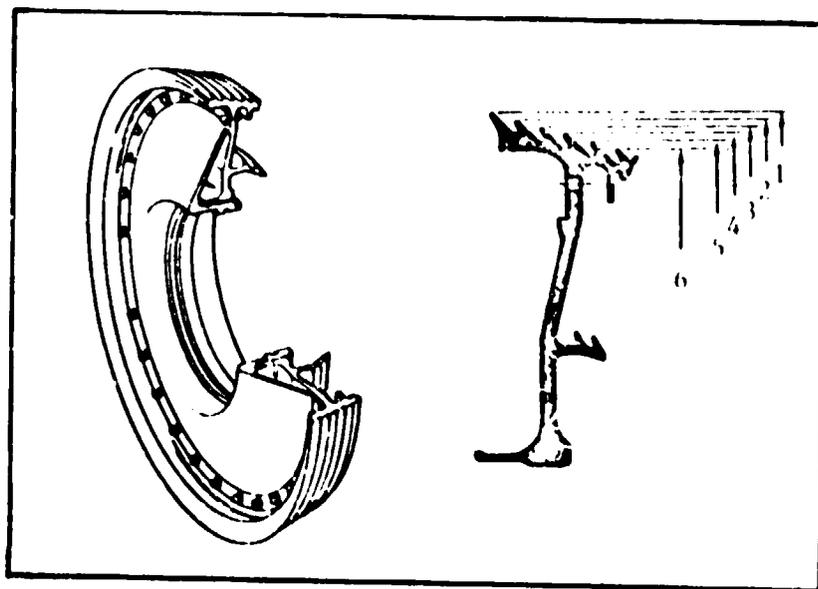
Figure B-5. Forward CDP Seal, Rotating.

A visual inspection revealed no discrepancies. Diameter and runout measurements of each of the CDP seal teeth, Figure B-5, were made and the results are shown in Table B-VI. (NOTE: The twelve o'clock position was arbitrarily chosen, and all measurements are relative to that point.) Calculations of the rotating seal to stationary seal (Table B-IX later in this report) clearances, as shown in Table B-VII indicated no measurable change from production nominal clearances.

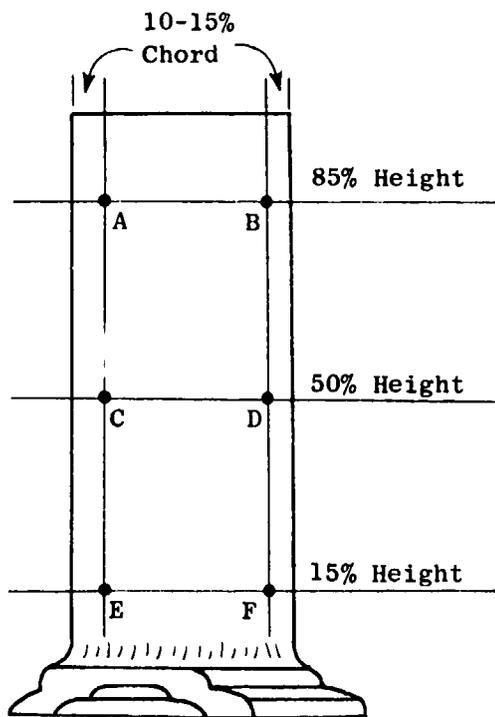
Figure B-7. Locations of Surface Finish Measurements - HP Compressor Sataor Vane.

87	15	10	10	12		15	18	20	19		
	88	12	13	13	13	21	16	20	18	18	20	
15	45	20	19	20	20		25	30	30	28		
	46	26	18	15	20		20	21	25	22		
	47	20	15	18	18		30	35	30	32		
	86	17	15	15	16		26	20	26	24		
	87	15	25	16	19		23	26	22	24		
	88	15	15	20	17	18	22	25	22	23	26	
OGV	59	20	21	21	21		22	20	24	22		
	60	20	15	18	18		25	26	30	27		
	106	15	15	20	17		15	18	18	17		
	107	24	18	19	20	19	19	24	22	22	22	
Average Vane Airfoil Surface Finish = 24 μ Inches AA Average New Part Finish = 28 μ Inches AA

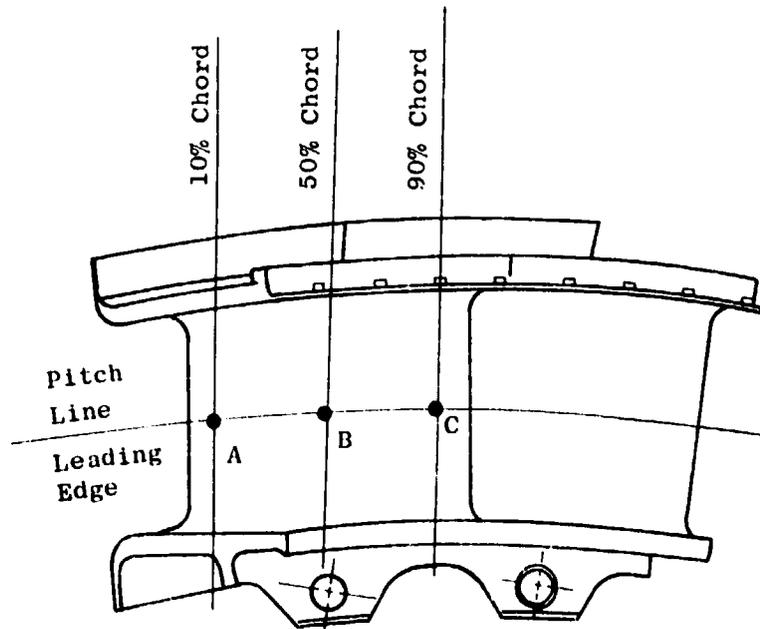
Figure B-13. HP Turbine Stage 1 Vane.

Six nozzles were removed from the Stage 1 high pressure turbine nozzle assembly to have their airfoil surface finishes inspected. Measurements were taken at the pitch line at 10, 50, and 90 percent chord on both the convex and concave surfaces (see Figure B-13). The results, as presented in Table B-XVII, show a small increase over the Shop Manual maximum limits of 39 μ inch for the convex (suction) side and 150 μ inch for the concave (pressure) side.

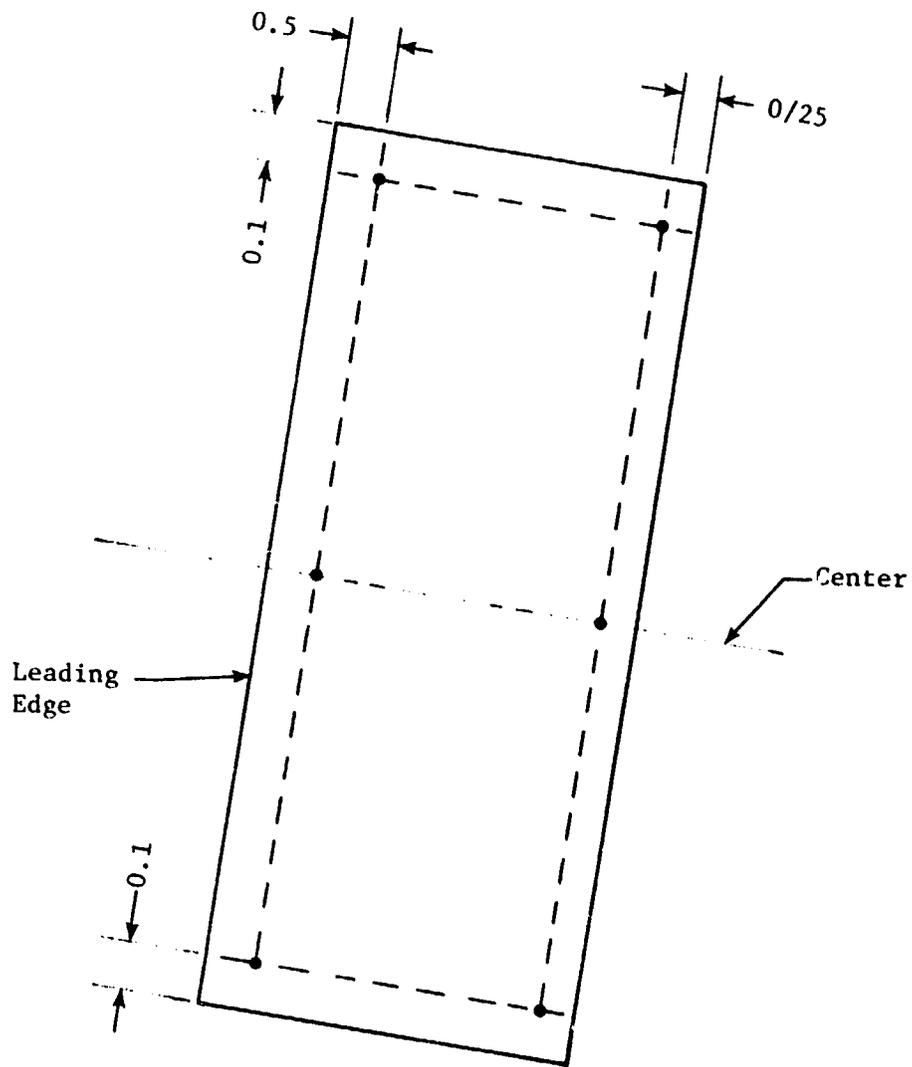
Figure B-17. Typical Stage 1/Stage 2 Shroud Measurement Locations.

An additional measurement of the Stage 2 shrouds was made at approximately 0.100 inches from the leading edge, which was outside the blade path and, consequently, the rubbed areas. The results are presented in Table B-XXIII. As can be seen, at this axial location there was up to 0.017 inch inward creep of the shroud ends.

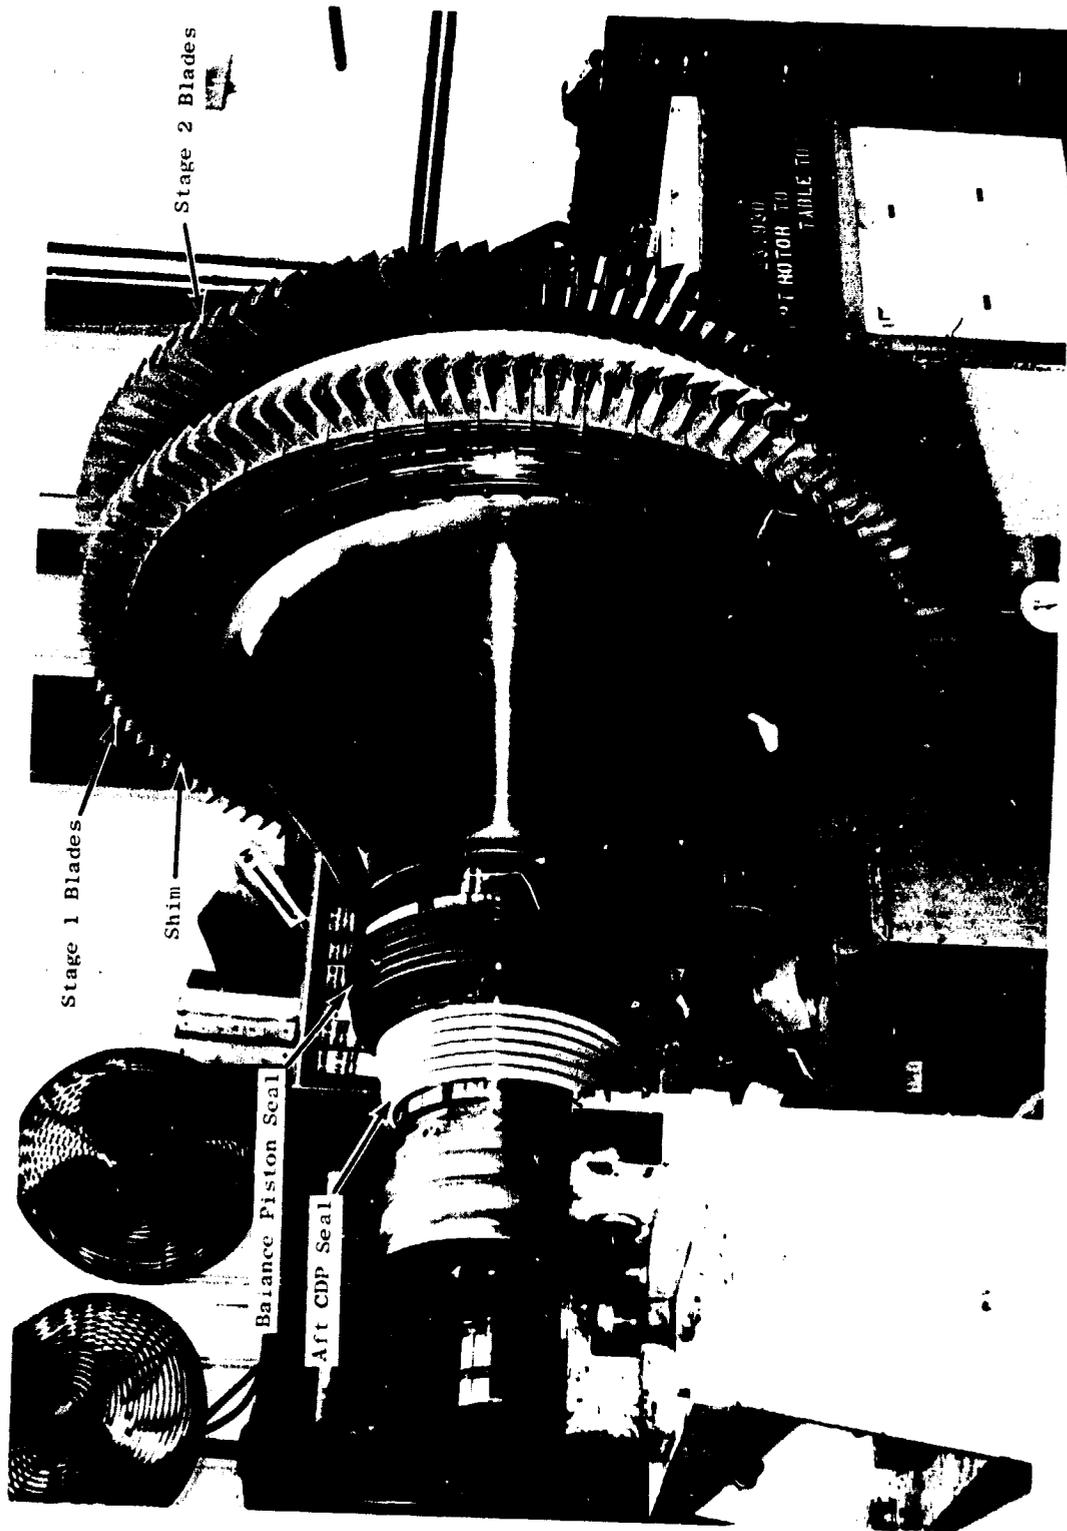
Figure B-22. High Pressure Turbine Rotor in Runout Fixture.

Except for heavy blade-tip rubs, the high-pressure turbine rotor was in excellent condition. No visible discrepancies were noted in any of the spool parts. The blade retainer seal wires were visually inspected and revealed good sealing contact.

An examination of the data shows how unevenly the blades had worn, both blade-to-blade and forward-to-aft. It also revealed how severe the tip rubs were. According to production records, the blade tip radii during the initial build-up were 16.589 inches for Stage 1 and 17.242 inches for Stage 2. Therefore, the average tip loss for Stage 1 was 0.025 inch; and for Stage 2, 0.020 inch. This condition was shown to be the major source of engine performance loss noted during parts inspection.

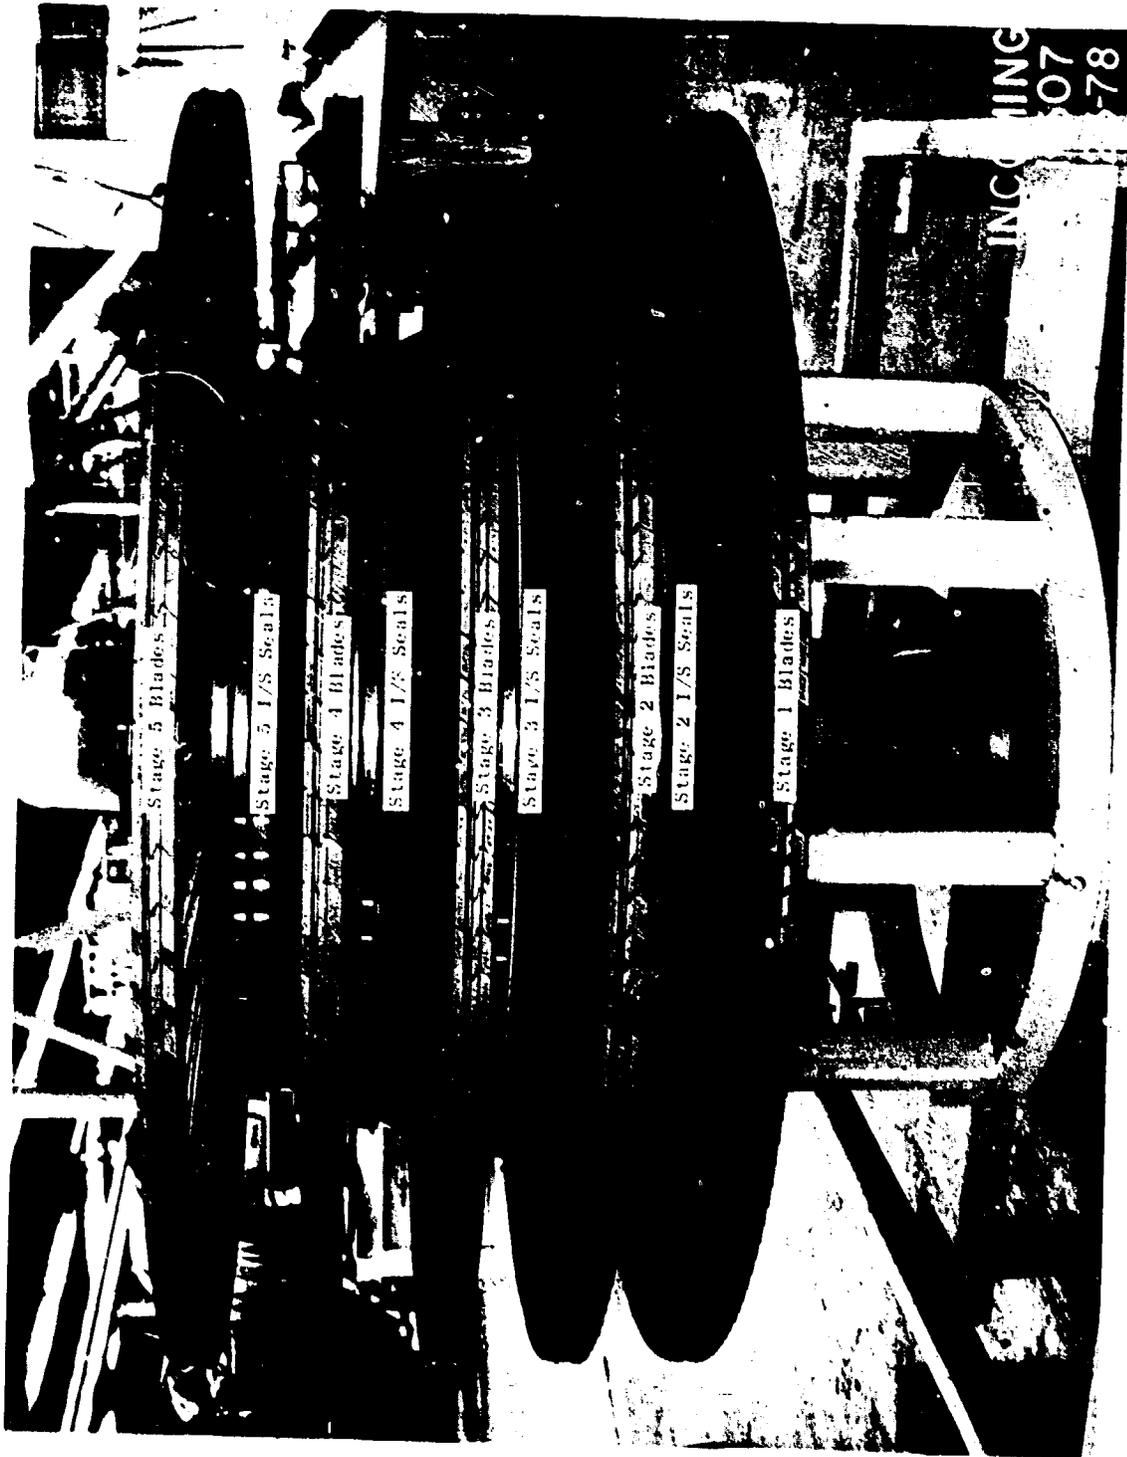
Figure B-29. Low Pressure Turbine Rotor.

Visually, the low pressure turbine (LPT) rotor assembly was in excellent condition. No FOD or other type of damage was noted on the airfoils, nor on the spool parts. A photograph of the rotor installed in its transportation fixture is presented in Figure B-29.
